The assessment, monitoring and management of hiking trails: a case study from the Stirling Range National Park, Western Australia

PAMELA MENDE AND DAVID NEWSOME*

School of Environmental Science, Murdoch University, Western Australia

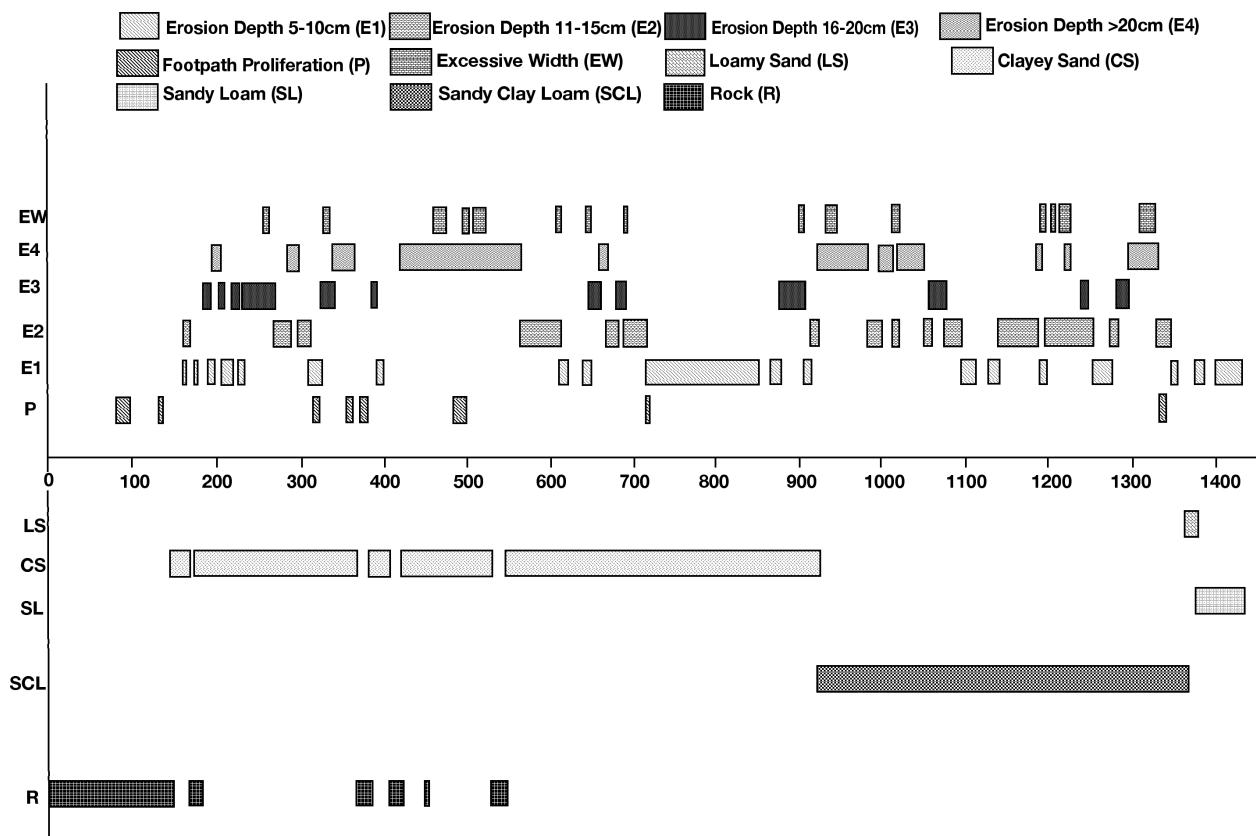
Erosion E1 was the most common degradation problem on the trails (Table 2). The Talyuberlup trail was the most eroded trail in the park (Figure 3). Talyuberlup had the highest average erosion E4 (23.8 m/100 m), E3 (10.3 m/100 m) and E2 (20.9 m/100 m), as well as the highest total erosion (78.1 m/100 m). The Red Gum Hill trail was the second most eroded trail in the park (43 m/100 m) and had the highest erosion E1 (40.3 m/100 m). The least eroded trail was the Toolbrunup trail, which had no erosion (Figure 4). Exposed roots were also found on all the trails (Table 3), mainly occurring in conjunction with erosion. Talyuberlup had the highest number of exposed roots (353), whilst Mt Trio had the least amount (43).

Figure 3. Location and lineal extent of degradation indicators and soil types on the Talyuberlup footpath. The path length is from the summit (0m) to the start of the path (1430).

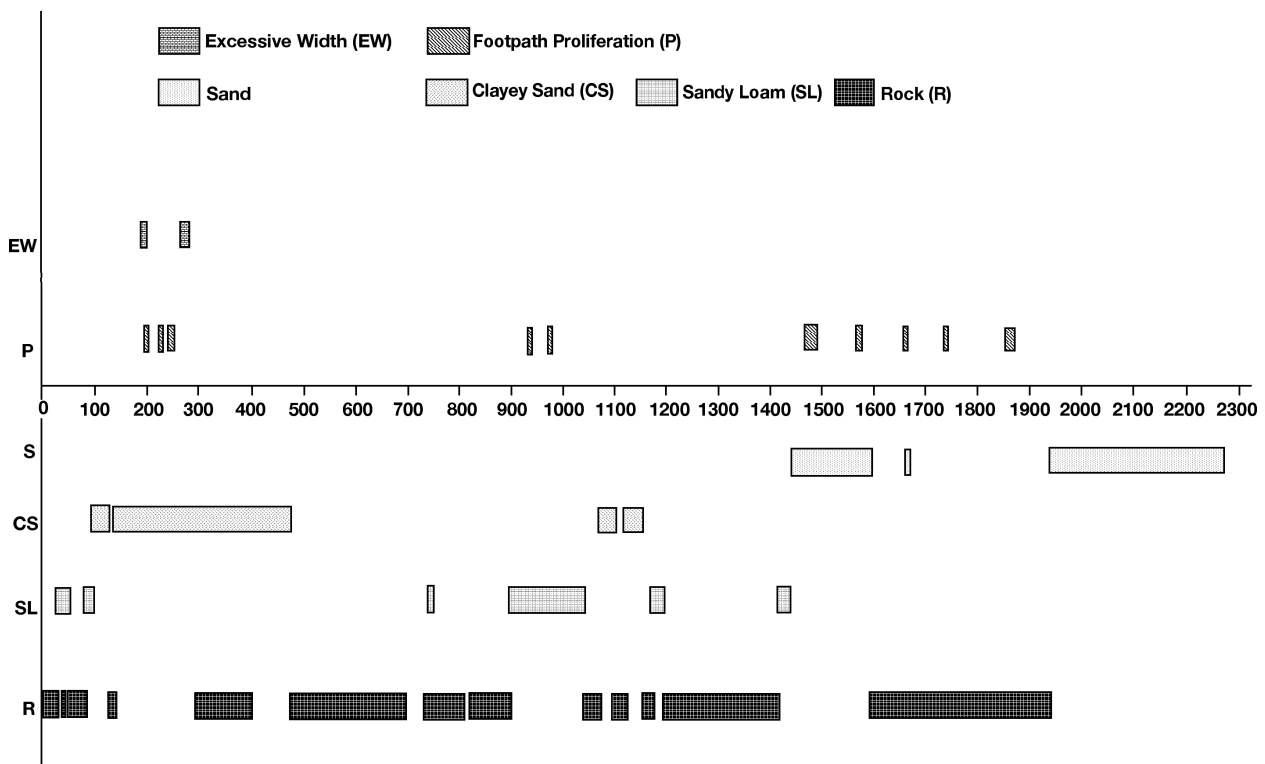
Figure 4. Location and lineal extent of degradation indicators and soil types on the Toolbrunup footpath. The path length is from the summit (0m) to the start of the path (2266m).

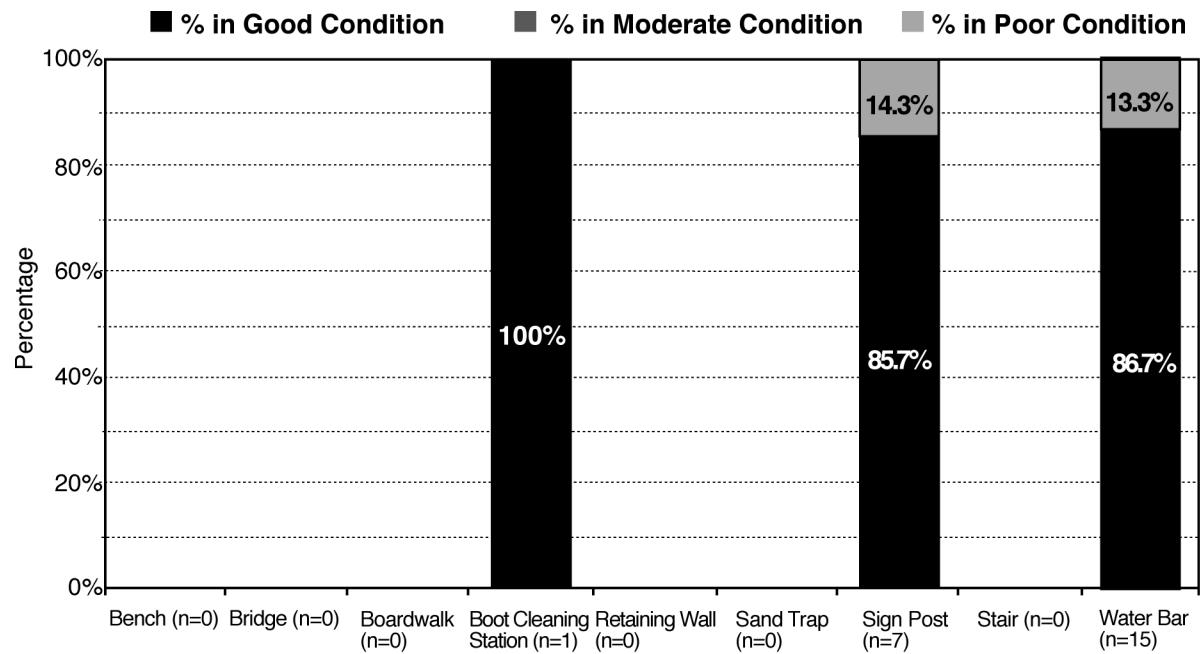
At least 79% of the constructed features found on each trail were in good condition (Table 4). The Toolbrunup trail had the highest percentage of constructed features in moderate condition (16.9%) whilst Talyuberlup (Figure 5) had the most constructed features

Figure 5. The percentage maintenance features on the Talyuberlup footpath classified as being in good condition, moderate condition and poor condition.

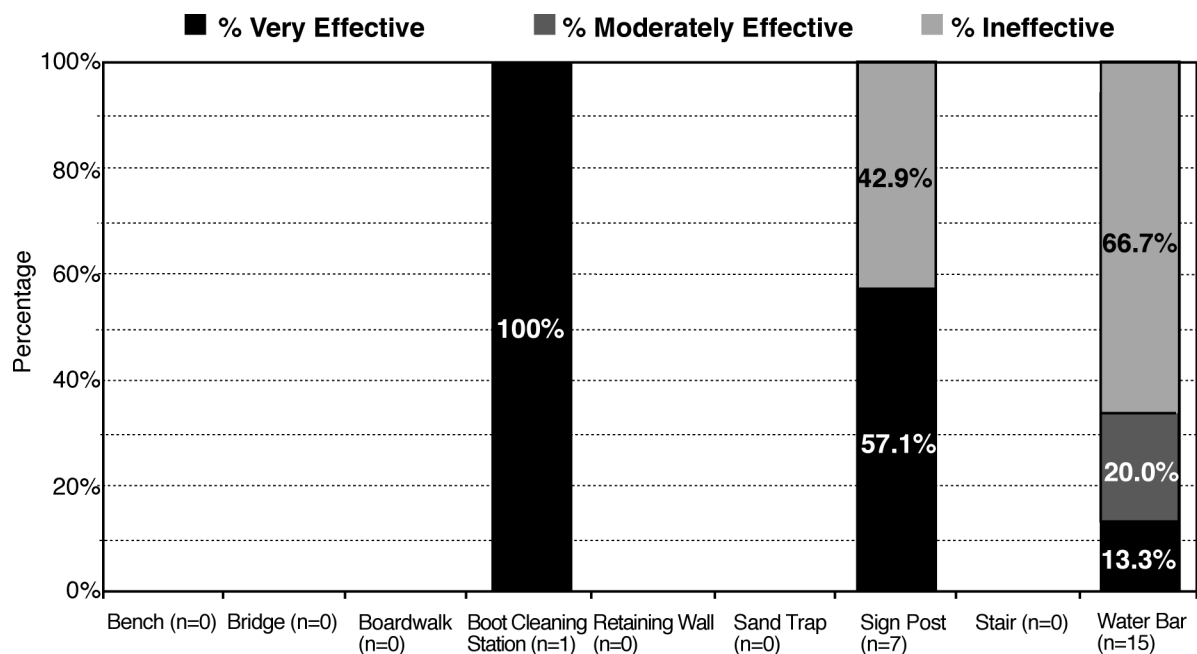
Figure 6. The percentage maintenance features on the Talyuberlup footpath classified as very effective, moderately effective and ineffective.

Regular trail maintenance should include the upkeep of constructed features, to ensure that they are in good condition and very effective. Some trails, such as Central Lookout and Talyuberlup had a high percentage of moderately effective or ineffective constructed features. This could be rectified by maintenance. For example, most of the water bars on the Central Lookout trail were moderately effective (54.8%) to ineffective (22.8%) because debris, namely gravel and small rocks, had built up around the water bars. Regular maintenance would keep water bars free of debris, making them more effective.
